YOUR INSPECTION REPORT

29 Oakmount Rd
Toronto, ON

INSPECTION DATE:
Tuesday, January 29, 2013

PREPARED BY:
Walter Collodel, P.Eng.

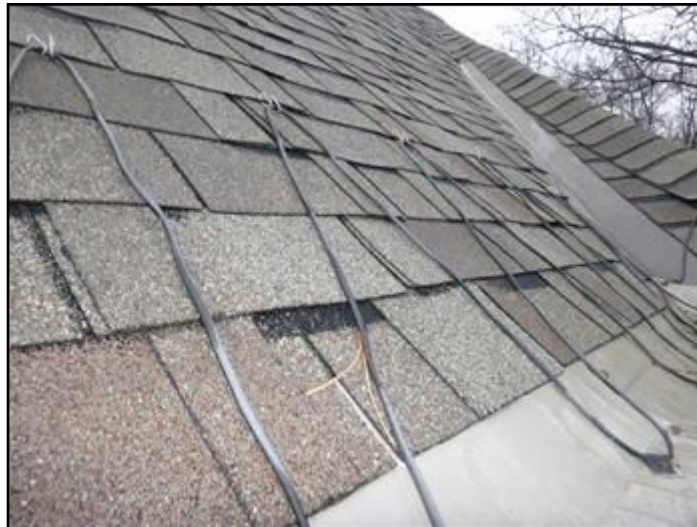
There are a lot of flashings associated with this roof covering. They appear to be well sealed but should be checked regularly. Ice melter cables were also noted on south facing portions of the roof but the seller reports that they are not used as the insulation levels in the roof space have been upgraded (see "insulation" section).

ice melter cables noted

Task: Inspect annually

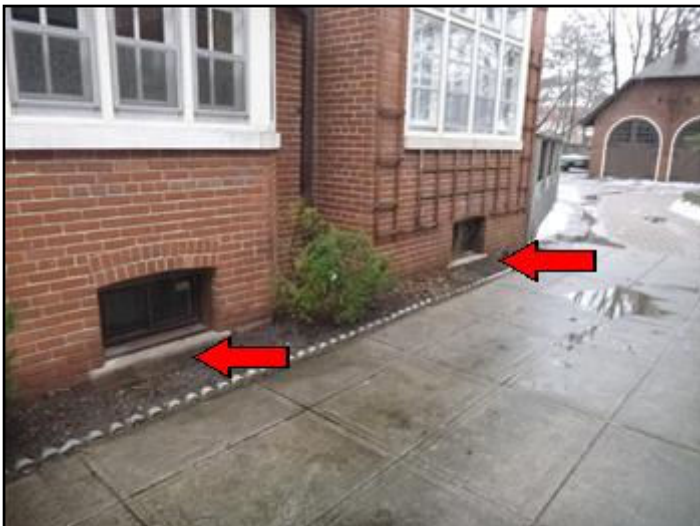
Many basement windows sit at or very close to grade level, making them very vulnerable to water entry. At a minimum, ensure that ice and snow are cleared from the areas in front of these windows.

windows at grade level (south side)

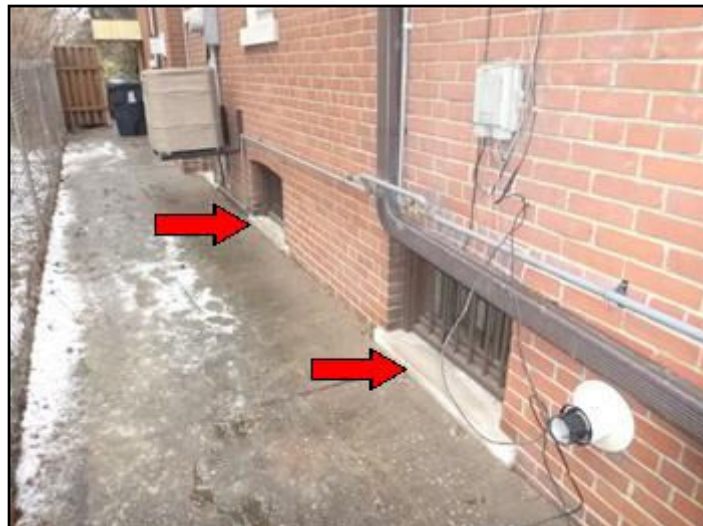
windows at grade level (north side)

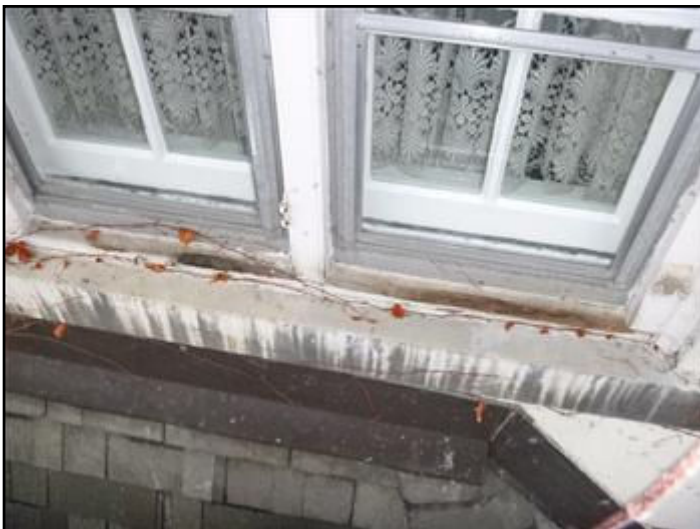
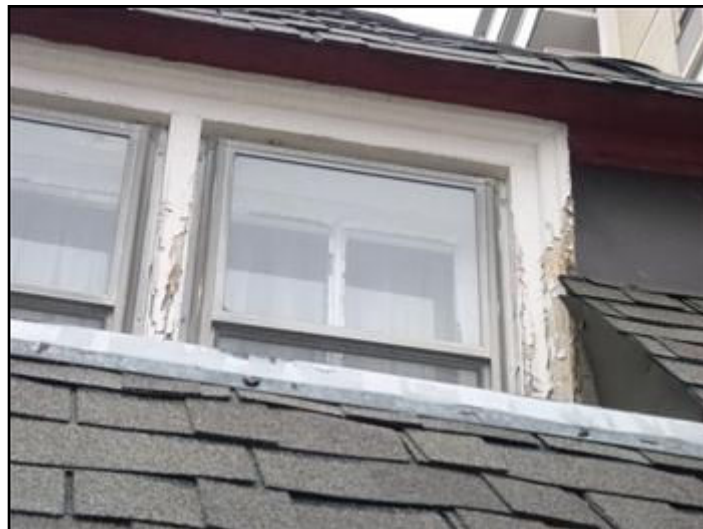
Wood is still in reasonable shape but needs a layer of paint for protection.

Paint/stain

Task: Improve

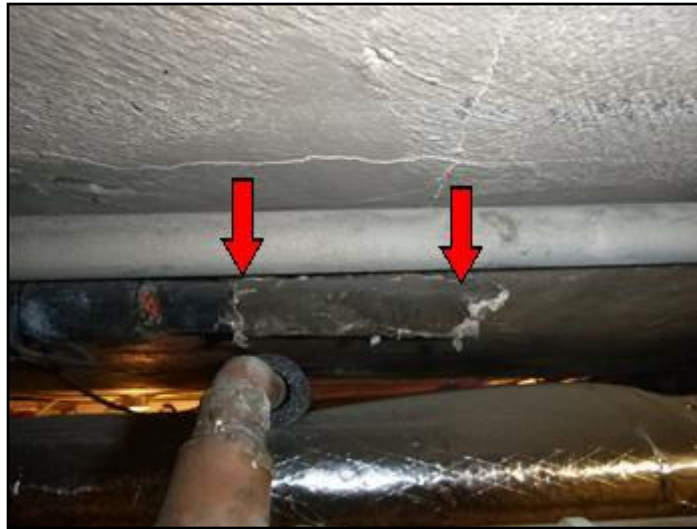
Seller reports that the old pipe wrap was removed and replaced with bubble foil insulation. This appears to be the case but there is a very short section of abandoned pipe that still has the older insulation on it. This doesn't really pose a risk as it is practically inaccessible.

short section of pipe with older insulation

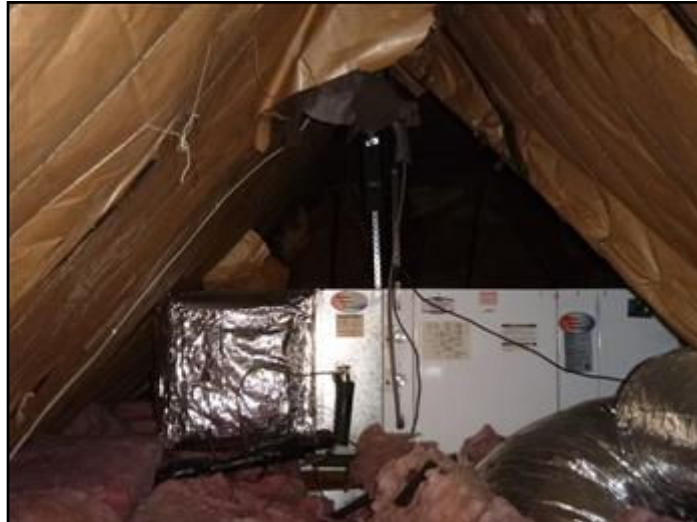
A/C air handler in attic space

Condition: • [Near end of normal life expectancy](#)

Continue to operate and service unit annually until replacement is required.

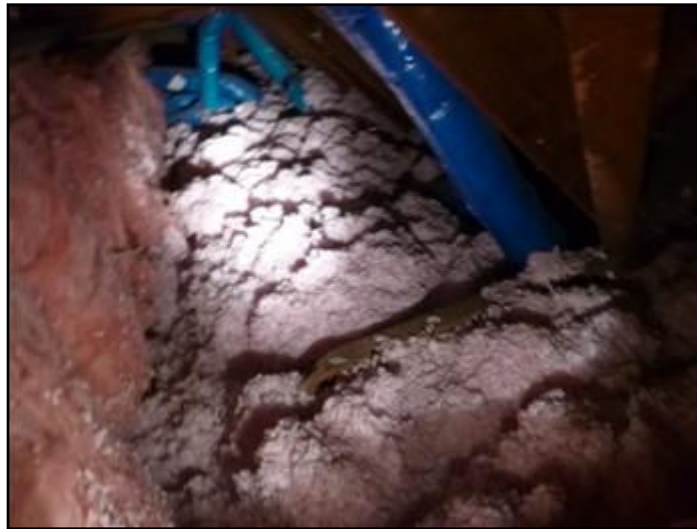
Condition: • Some evidence of vermin activity was noted in the attic. This is not unusual and no action is required. If activity is detected, a pest control company can be contacted for assistance.

Seller reports that there was some activity in the past but has had it addressed. The evidence noted was older activity.

Some evidence of vermin activity was noted

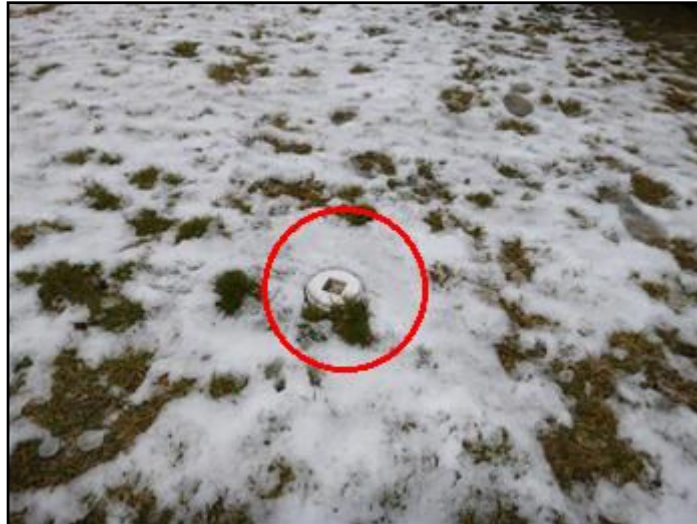
Condition: • Prior repairs noted; see Seller for repair details and warranty information
Seller reports that a good portion of the waste pipe between the house and the sewer has been upgraded.

newer plastic clean-out noted at front yard

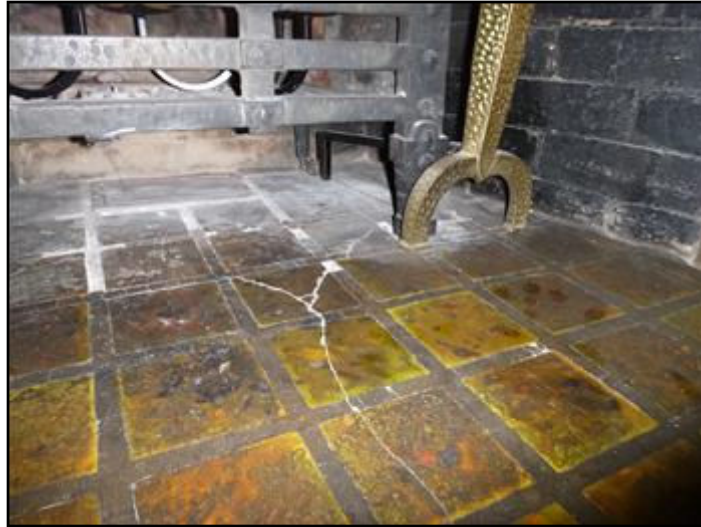
Condition: • [Firebox gaps/cracks](#)

Firebox gaps/cracks

Task: Repair

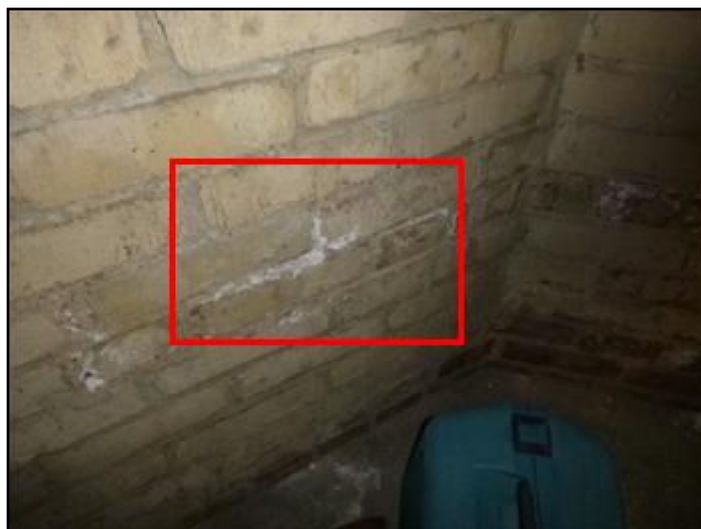
Condition: • [Efflorescence](#)

Efflorescence is common in houses of this age and type of construction. Provide a dehumidifier to keep the humidity levels down (if necessary). Water management improvements are needed at the front garden area (see "exterior" section).

Efflorescence
