YOUR INSPECTION REPORT

29 Oakmount Rd
Toronto, ON

INSPECTION DATE:
Tuesday, January 29, 2013

PREPARED BY:
Walter Collodel, P.Eng.

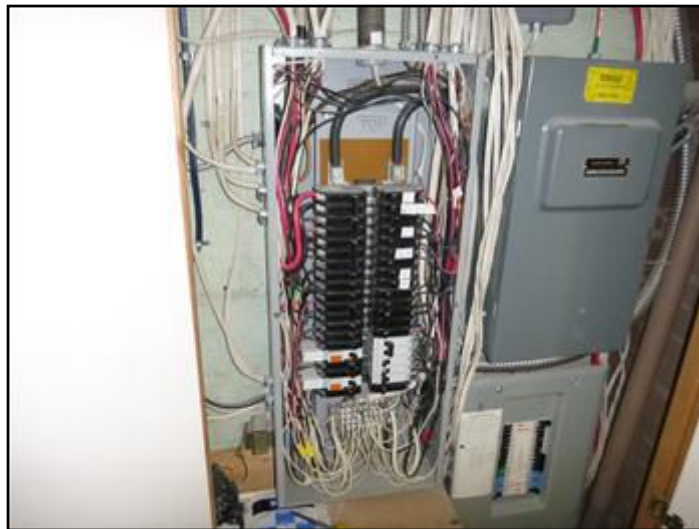
Breakers - basement

A handful of double-tapped breakers were noted on the main panel (which is completely full). A sub-panel will have to be installed if nuisance tripping becomes a problem (not anticipated).

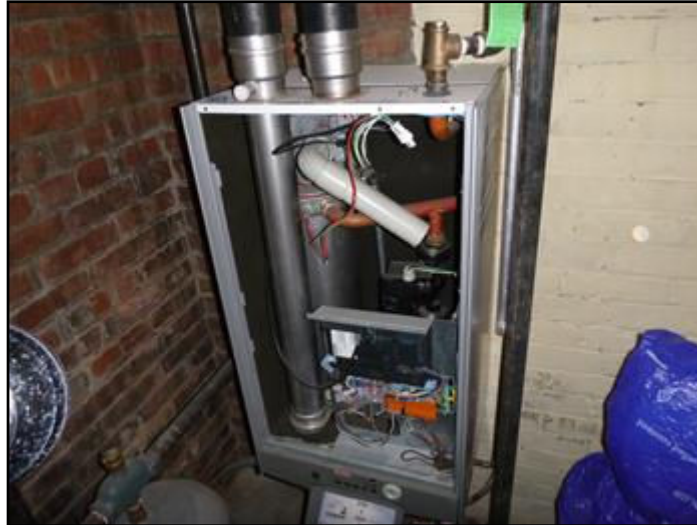
Boiler

Condition: • The insulation on the boiler or heating pipes may contain asbestos. Health Canada recommends the insulation be left in place undisturbed. If the insulation is damaged or is to be disturbed, and if it contains asbestos (confirm with Laboratory test), precautions should be taken that asbestos fibers are not released into the house air during the work. Please see the Asbestos article in the Supplementary section of the text.

Seller reports that the old pipe wrap was removed and replaced with bubble foil insulation. This appears to be the case but there is a very short section of abandoned pipe that still has the older insulation on it. This doesn't really pose a risk as it is practically inaccessible.

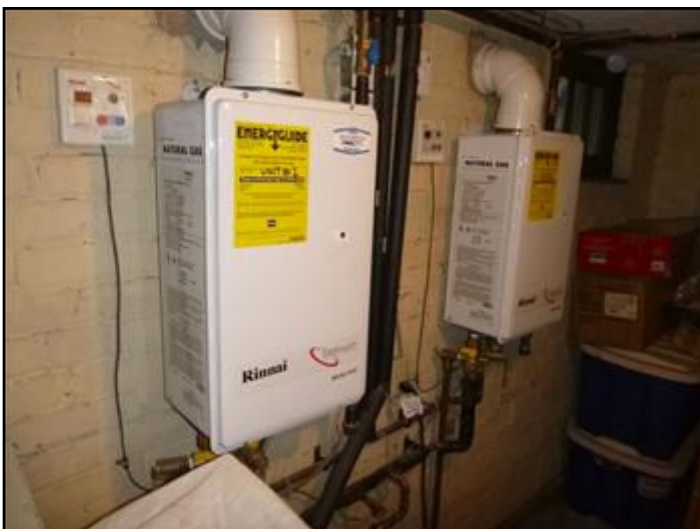
Hot water is generated by a pair of tank less water heater units. The system is fairly sophisticated with switchgear that alternates operation of the units and a small two gallon buffer tank to ensure steady hot water delivery.

two tank less water heaters are used

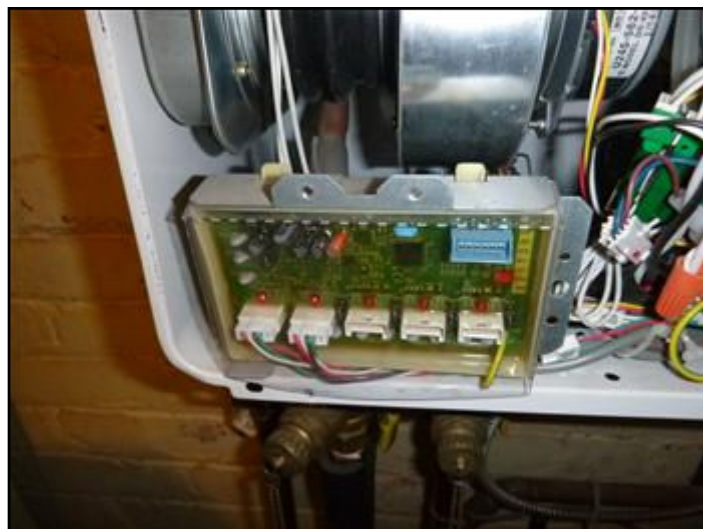
switching equipment

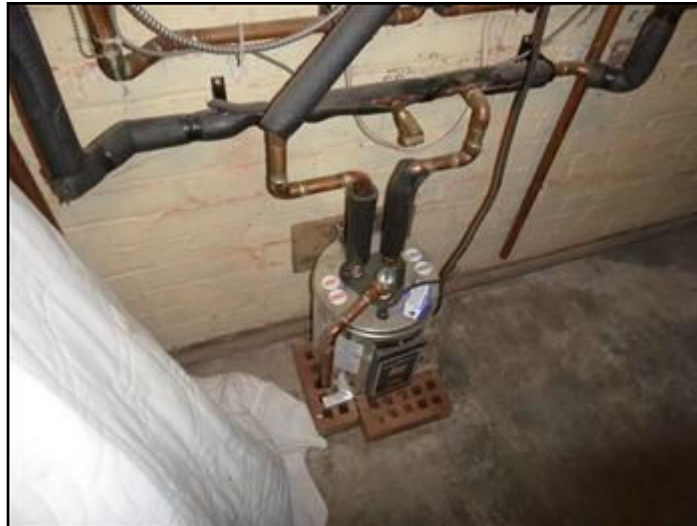
This system actually uses a small storage tank to ensure constant water temperature.

small storage tank
